Erla Guðrún Hafsteinsdóttir Umhverfis- og jarðefnafræðingur, PhD VAFRÍS morgunverðarfundur 23. október 2024

### Jarðvegsmengun - Áskoranir á Íslandi -

# Contaminated Land – presentation overview

### Vapour Intrusion Case study - N1 Petrol Station in

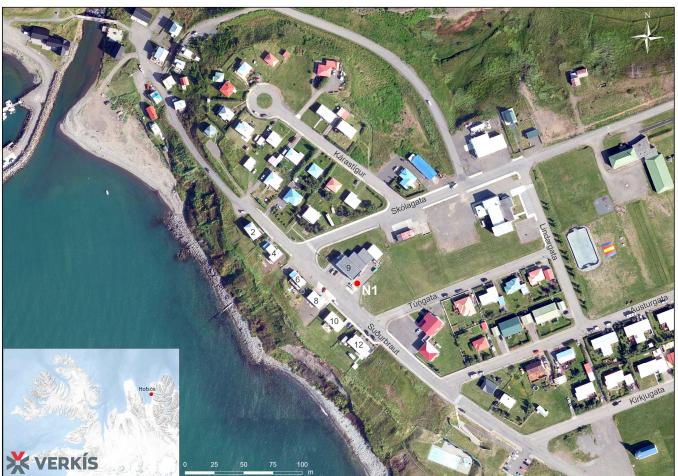
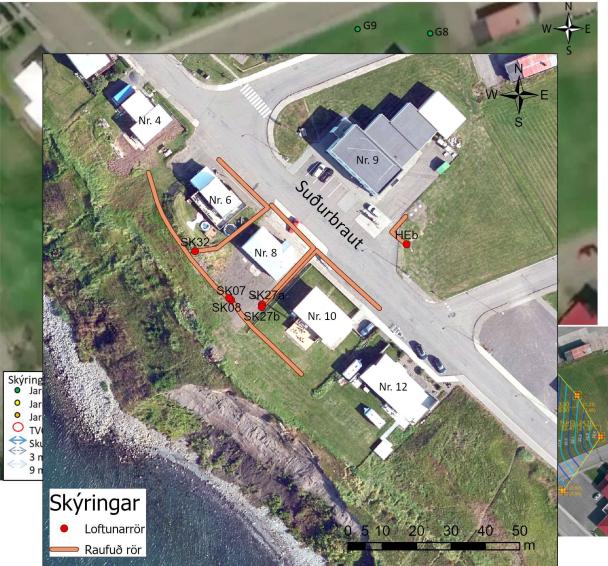
- Petroleum odour
  - First complaints of odour from drains was received by N1 during autumn 2019
  - Odour also detected indoors in two buildings near the petrol bowsers

- <u>Remediation</u>
  - Vapour intrusion mitigation methods
    - Sub-slab active vapour extraction
    - Ventilation in buildings
    - Sealing preferential pathways through floor slabs
  - Clean-up
    - Soil vapour extraction & biodegradation
    - Removal of contaminated soil
  - More detailed investigation
- July 2022, ongoing:
  - VOC monitoring
