VAFRÍS

Áhrif eldsumbrota á neysluvatnsból Reynsla HS Orku

Valdís Guðmundsdóttir
Project Manager

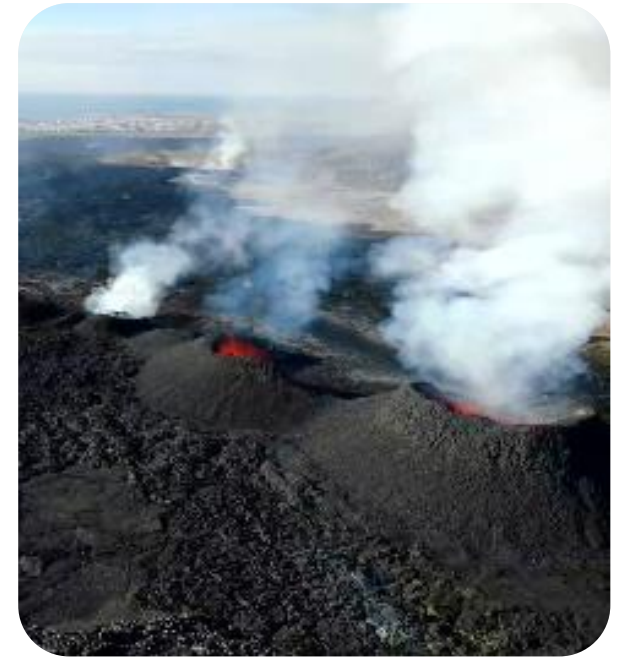
Online loggers installed

Intended to capture any change that could be due to volcanic contamination

- Fluoride
- Temperature
- pH
- Conductivity
- Turbidity

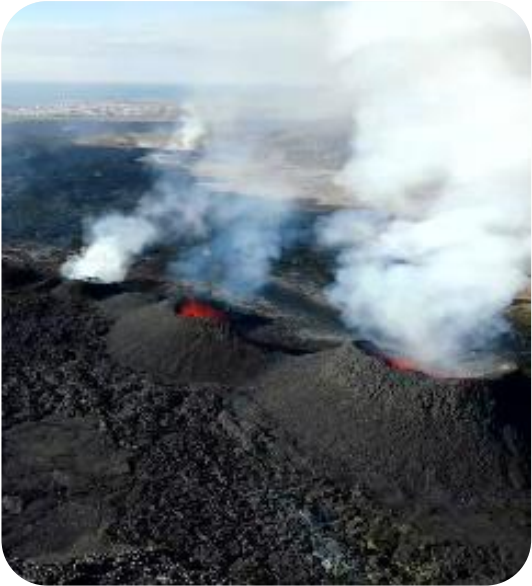
Sundhnúkar eruption

Online loggers don't show any noteworthy changes in the water source at Lágar

Has taught us a lot about groundwater in Reykjanes

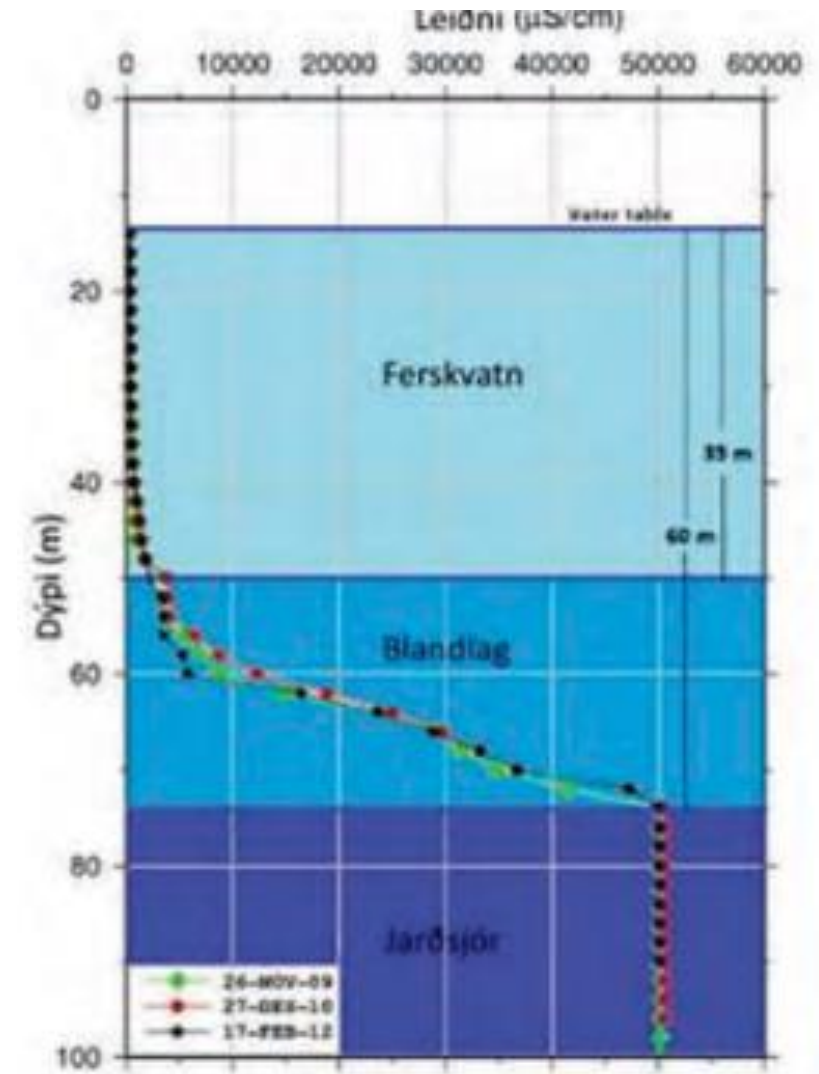
The Reykjanes ground water lens

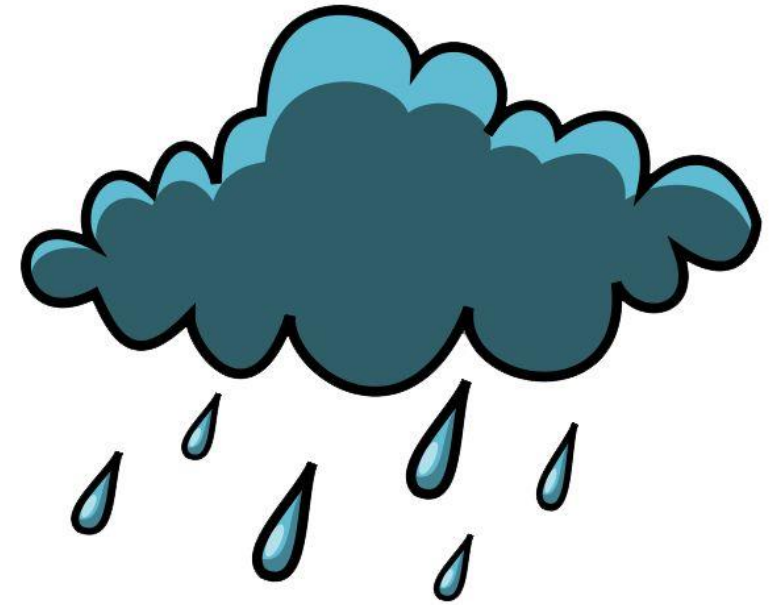
Renewal and discharge

- Ákoma : 1100 mm á ári eða 10549 L/s
- Afrennsli : Lek berglög í sjó, 2%?
- Aðrennsli : Óþekkt
